Manhole Inspection Summary

Manhole # S33OO_005MH

Insp Date: **6/8/07 12:44 AM**

Location Address: **102 24TH ST**

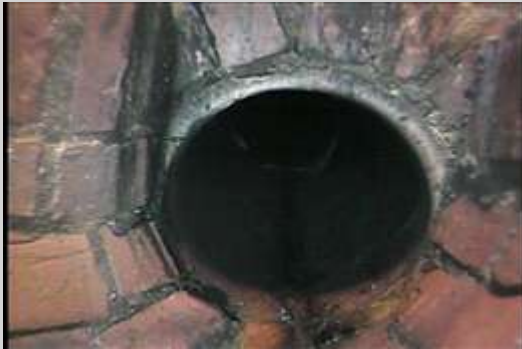
8 in. Circular Gravity Sewer Pipe Out @ 12 O'Clock

Rod and Bar (Angled)

Pipe Material: **Clay** ☐ Pipe Lined

Infiltration: **None** Pipe Seal Cond: **Unknown**
